# FINAL FIRST FIVE-YEAR REVIEW REPORT FOR OPERABLE UNIT 2 AND OPERABLE UNIT 4 SCHOFIELD ARMY BARRACKS, ISLAND OF OAHU, HAWAII

Prepared for U.S. Department of the Army U.S. Army, Hawaii

Prepared by **Harding ESE**

Harding ESE Job No. 53744 06.01 Contract No. GS10F0157K Order No. DAPC50-01-F-0106

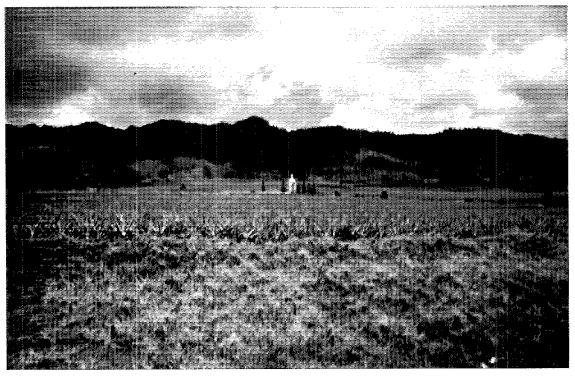
Air Stripper for Del Monte Water Treatment System

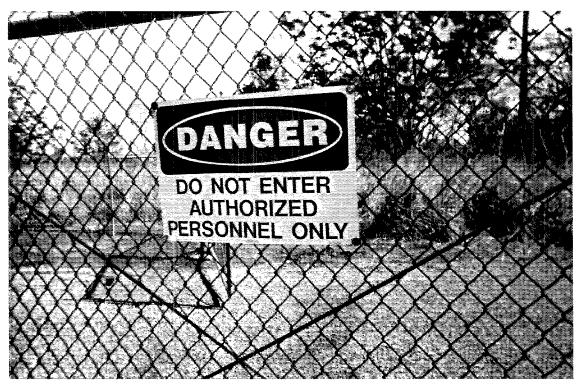
Posted sign on security fence around Operable Unit 4

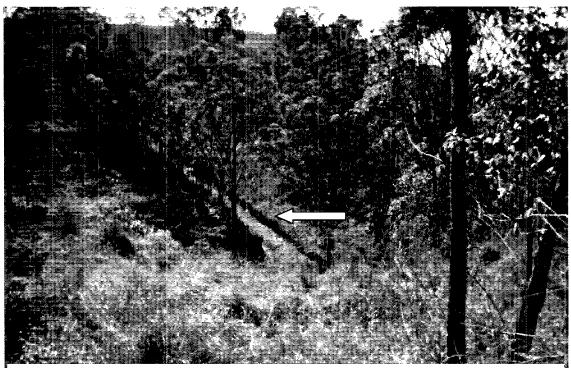
North central sideslope drainage chute near outlet structure

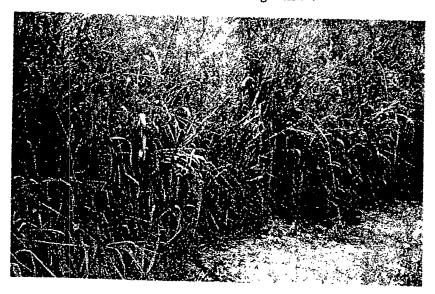
Guinea grass overgrowing the fence on eastern boundary of landfill

Recommended corrective actions. Controlling of the Guinea grass continues to be the single largest challenge at the former landfill site. Recommend landscaping contractor continues to herbicide Guinea grass to the west of the central swale to bring under control. Also recommend cutting and herbiciding of the Guinea grass on the northern slopes to bring under control. The drop pit at the bottom of was cleaned out subsequent to the inspection and has been restored to its fully functional state.

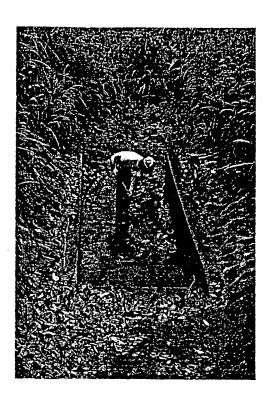
Mud being cleared at Drop pit energy dissipater outlet At bottom of Central Drainage Chute

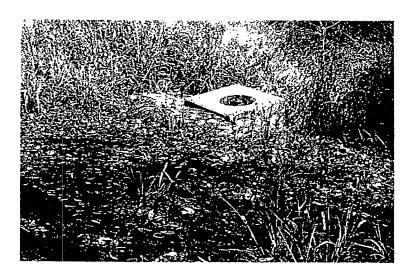
Junction box Central Drainage Chute
